HYGEIA INC.

REPORT AND RECOMMENDATIONS OF THE SURVEY FOR ASBESTOS AND PCB-CONTAINING MATERIALS AT THE PROPOSED COMMONWEALTH CENTER DEVELOPMENT SITE, WASHINGTON STREET, BOSTON, MASSACHUSETTS

VOLUME ONE  
SURVEY REPORT OF  
ASBESTOS AND PCB-CONTAINING MATERIALS  
COMMONWEALTH CENTER DEVELOPMENT SITE  
BOSTON, MASSACHUSETTS

May 31, 1989

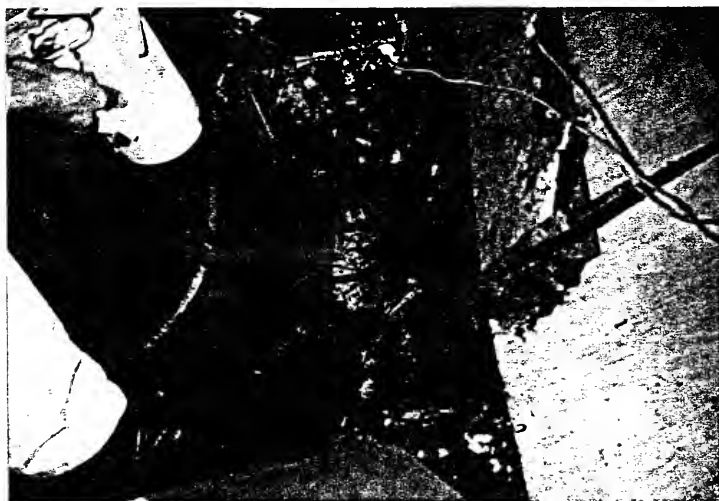
#2: View into pipe chase below tunnel from St. Francis House to Boiler Room

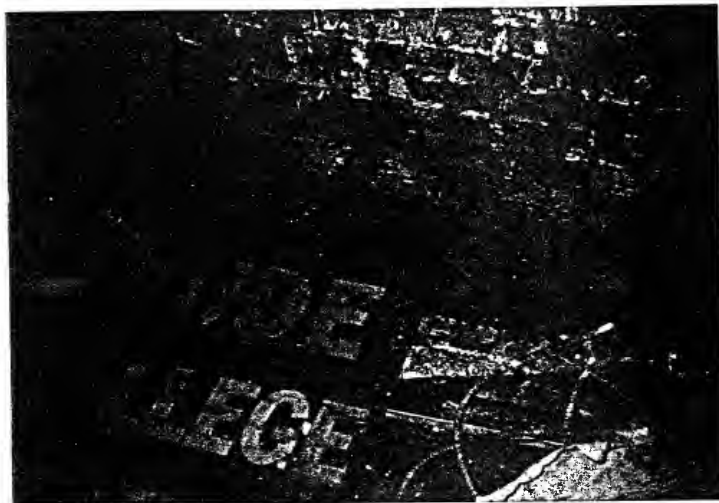
#3: Contaminated debris - tunnel from St. Francis House to Boiler Room

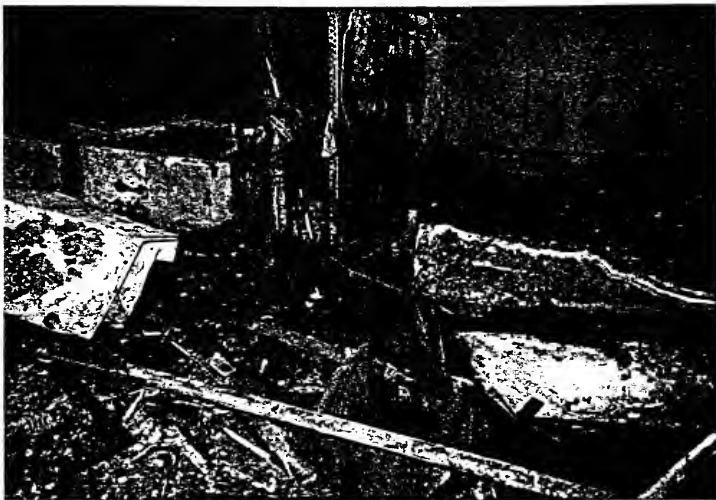
#11: Contaminated debris - basement of first floor lounge

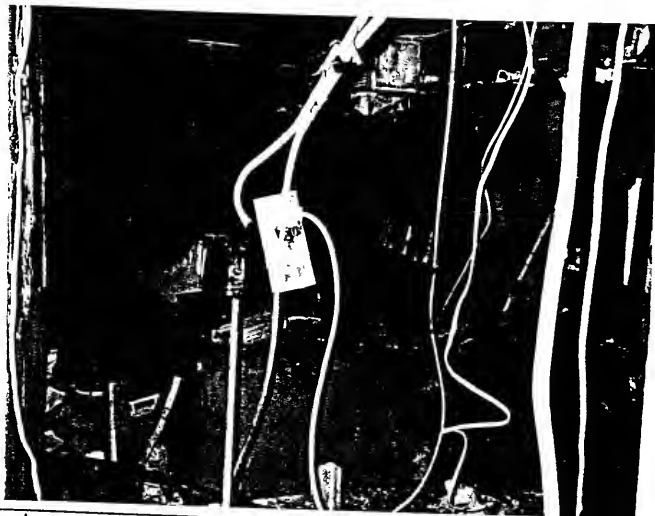
#13: Contaminated debris - basement of first floor lounge

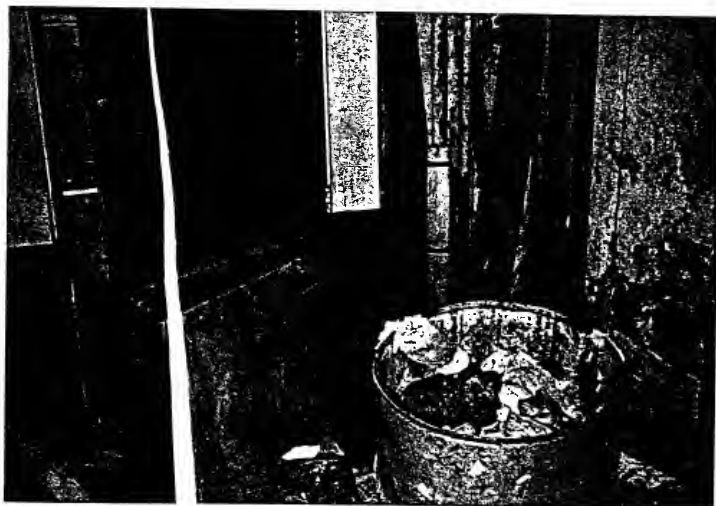
#28: Contaminated debris - basement

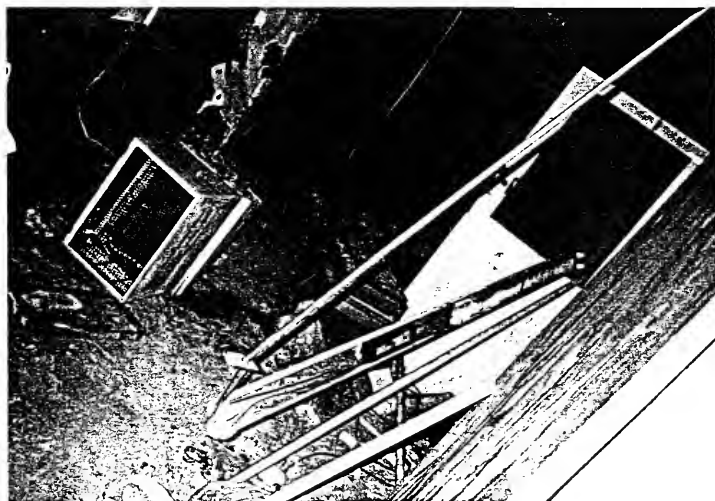
#30: Contaminated debris - basement

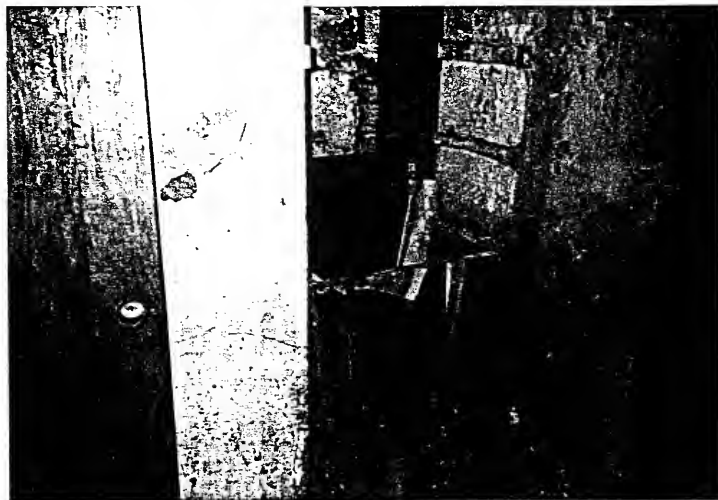
#35: Contaminated debris - basement

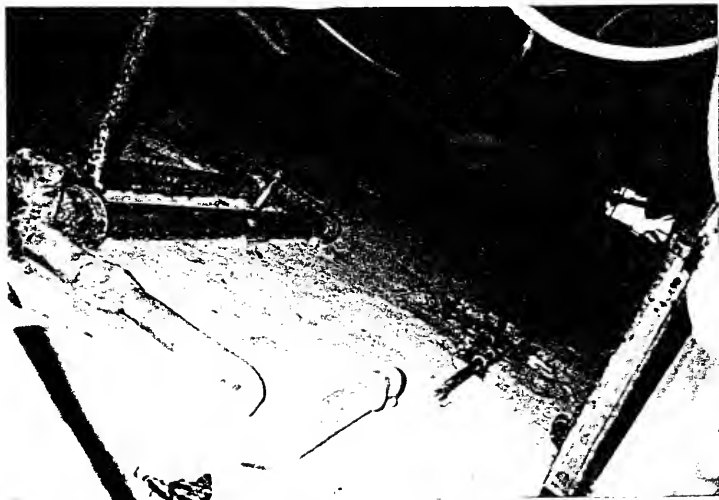
#50: View upwards in vertical chase between rooms

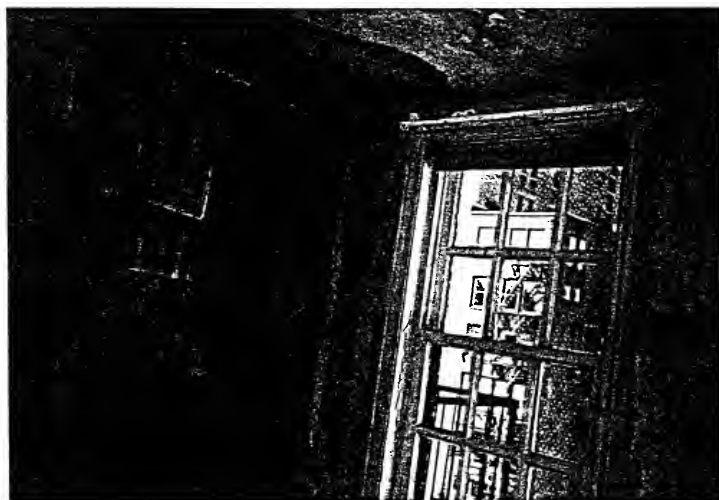
#52: Collapsed chase wall - back section Avery

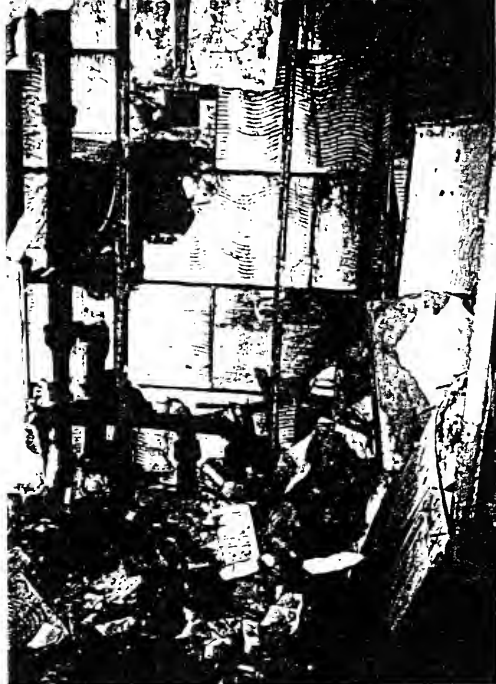
#53: Collapsed chase wall - back section Avery

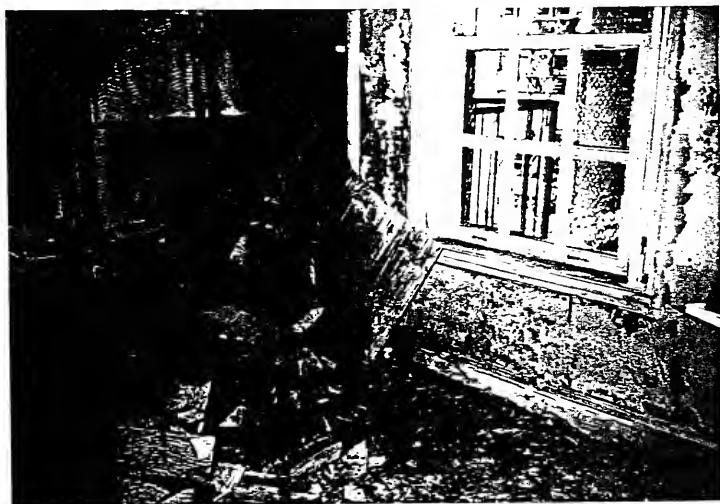
#54: Collapsed chase wall - back section Avery

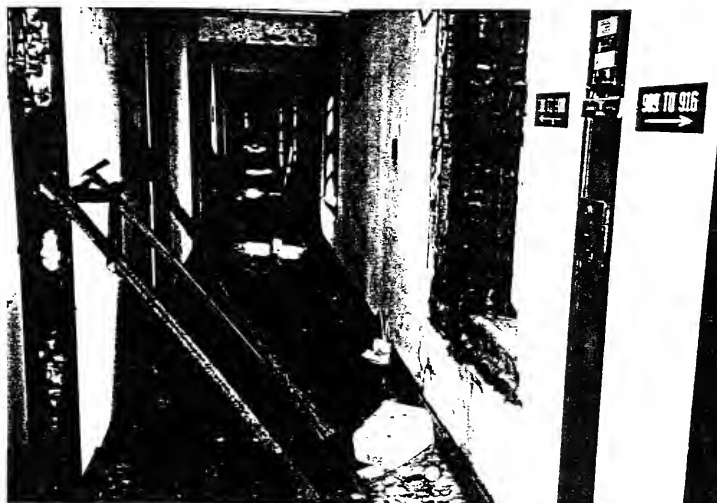
#55: View of contaminated debris in hall - ninth floor

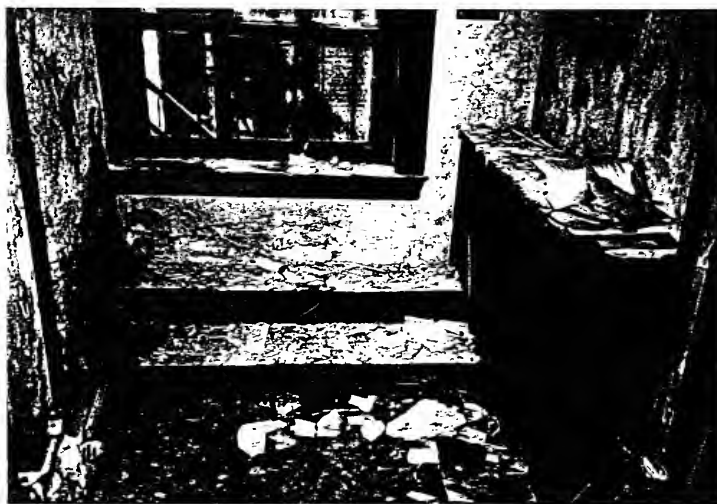
#56: Contaminated debris - ninth floor

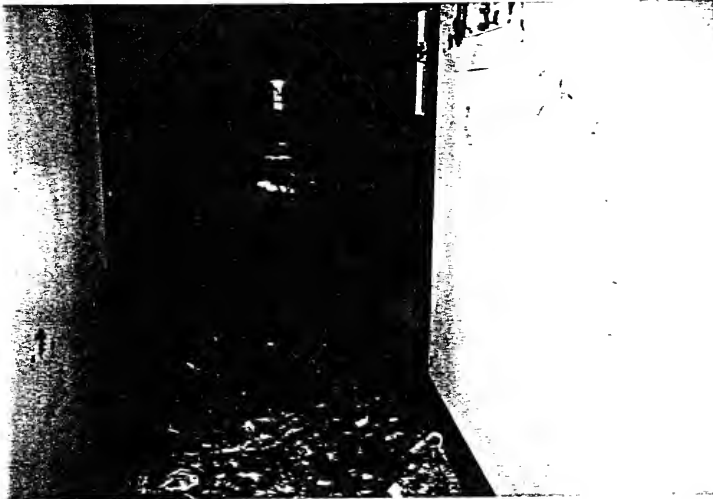
#57: Contaminated debris - ninth floor

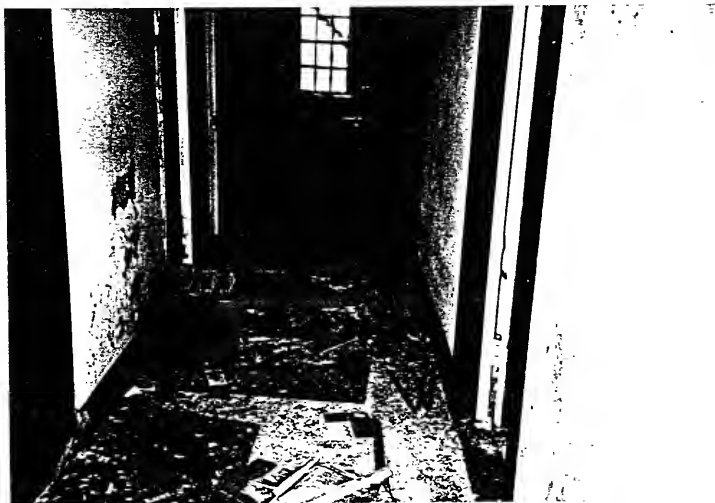
#58: Contaminated debris - ninth floor
